Nepal Health Sector Support Programme III (NHSSP – III)

**Joint Hospital Assessment Report – Karnali Province
Salyan Hospital
Final Draft
26 August 2019**

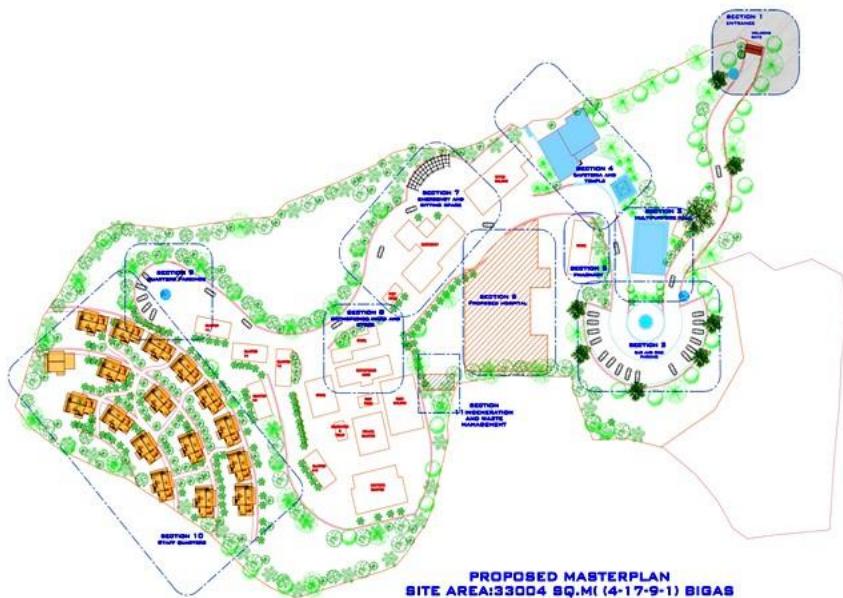
Figure 3: Proposed Master Plan prepared by Hospital Management in 2015

Development initiative: The hospital management prepared a master plan in 2015 for its expansion to 50 bed capacity with increased specialist services (see Figure 3). This is still relevant and will serve to support the upgrade of the hospital to Primary A3 level.

The draft master plan need to be revisited to make it as an integrated Master Plan that guides future development of the hospital in line with Multi-hazard resilience perspective and that address identified needs and following issues.

- **Site efficiency:** The proposed Master Plan is largely focused on construction of additional structures. While there is a role for new-build, consideration must also be given to maximizing use of the current buildings, and ensuring that there is efficient use of the built fabric. The Master Plan needs to be revised to document fully the existing structures, clearly identifying which should be demolished, reconstructed and/or retrofitted. New structures should be planned in relation to the efficient use of existing structures. This revision should also be carried out with the Standard Guidelines 2017.

- **Design aspects:** Many of the existing structures are attractively built, with exposed stone masonry structures. This style not only reflects local heritage and local architecture but also reduces maintenance costs. The revision of the Master Plan should support the addition of extra floors extending the external stone-facing walls. Hence, Additional and expanded services can also be located in new building blocks, but design should be appropriate and blend with existing buildings.

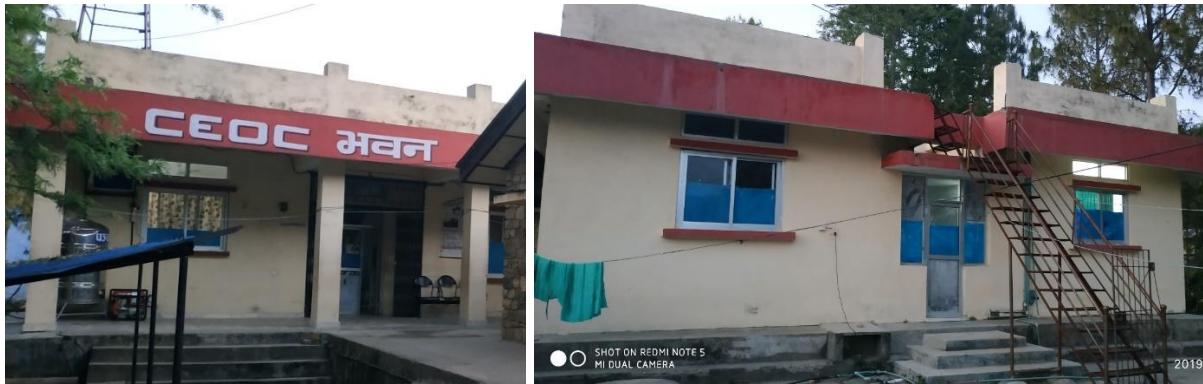
Figure 4: CEONC Block

The CEONC block was built in 2068 BS (2011) using the standard type design (see Figure 4). However, it is used currently only as an OT, while the delivery room, sluice, and other spaces are not used for the purposes they were designed for. This may be because the hospital

management was never given an orientation on the plan and design of the buildings during and after the construction of the building.

The CEONC block was built in 2068 using the standard type design, however the Delivery room, Sluice and other spaces are not used for the purposes they were designed. Management and staff should be given a re-orientation and briefing on the layout, functions and operation of the CEONC to maximize effective and safe use of the space.

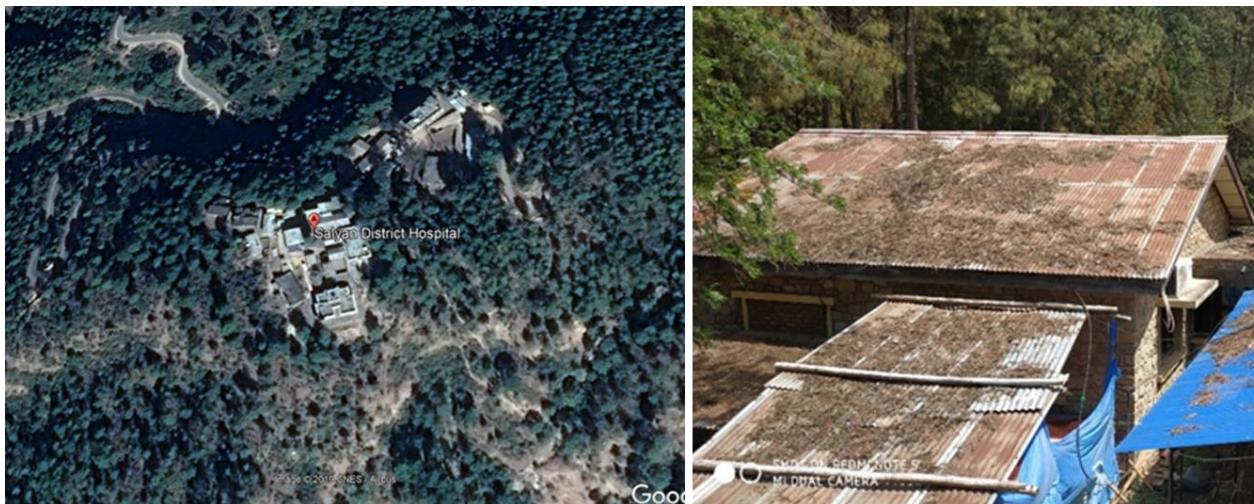
The hospital is surrounded by pine forest (see Figure 5a), and dry pine leaves collect on building roof tops. This increases the risk of fire (see Figure 5b) and must be addressed by ensuring dead leaves are not allowed to build up. There was a forest fire two years ago, and the need to prepare for such incidents in future should be addressed in the hospital disaster management plan and emergency drills.

Figure 5: Salyan Hospital surrounded by forest (left) and dry pine leaves on building roofs (right)

Visible deterioration of the building fabric – particularly seismic bands and exposed reinforcement - should be repaired. Roofs should be kept clear of dried leaves and tree debris to reduce fire hazards. Hospital management should initiate a regular cycle of building maintenance.

Hospital management should develop and adopt a Disaster Management Plan for mitigating all risks and hazards to the facility. Given its location, the Plan should pay particular attention to fire dangers.

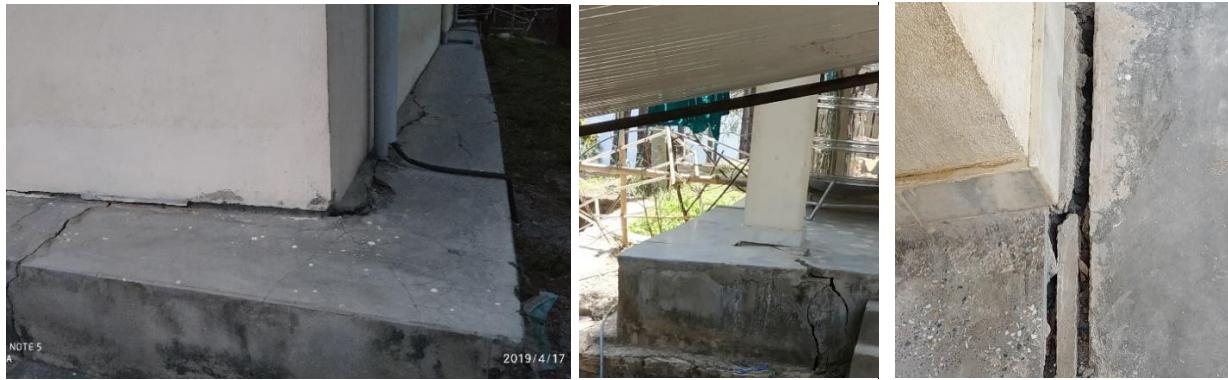
Cracks and settlement damage were observed in the CEONC eastern side apron and retaining wall (see Figure 6). Hospital staff reported that this damage was a result of the Gorkha Earthquake 2015.

Figure 6: Cracks and settlement CEONC building walls and apron

The cracks, settlement and foundations at the left/north side of the CEONC building and retaining wall should be given a detailed examination, and appropriate repairs made.

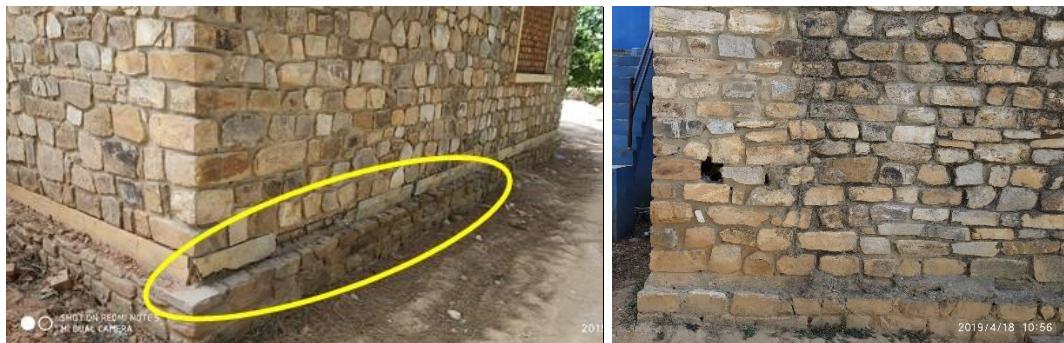
The NHSSP team observed various examples of deterioration in the built fabric due to lack of maintenance. These include corrosion of seismic bands in stone masonry building and exposed reinforcement (see Figure 7).

Figure 7: Exposed reinforcement

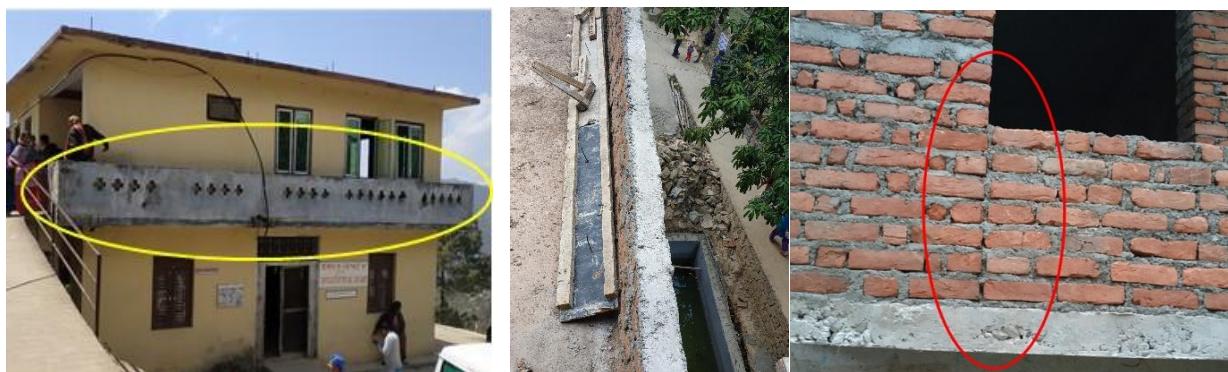
The assessment exercise recorded weak parapet walls in the Emergency block as shown below. in the following photo. In the new In-patient building (under construction) there as a vulnerable single brick parapet wall at the edge of the roof slab, and inadequate bonding in the brick masonry work (see Figure 8).

Figure 8: Vulnerable parapet (left) and inadequate brick bonding (right)

The parapet wall of emergency building at first floor is vulnerable. It should be removed.

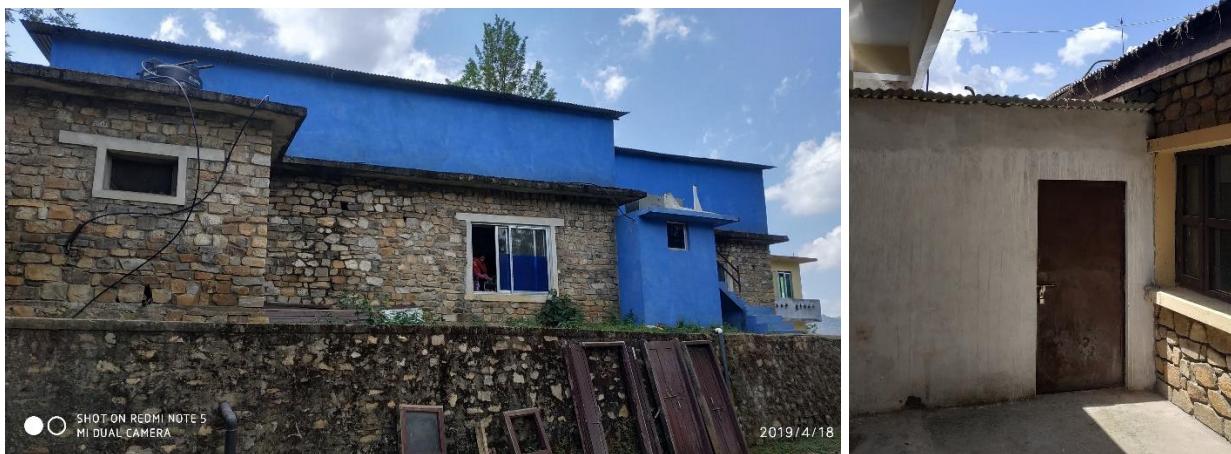
A new story has been added to the Delivery block and Biomedical engineering department block using prefab materials (Figure 9 left). In the opinion of the NHSSP team the quality of this construction is very poor. In addition, additions have been built between two building blocks as shown in Figure 9 right. These type of unplanned extension affects structural integrity of the blocks, causes maintenance problems and increases seismic vulnerability.

Figure 9 Extension of floor on the delivery block and biomedical engineering department (left) and additional blocks (right)

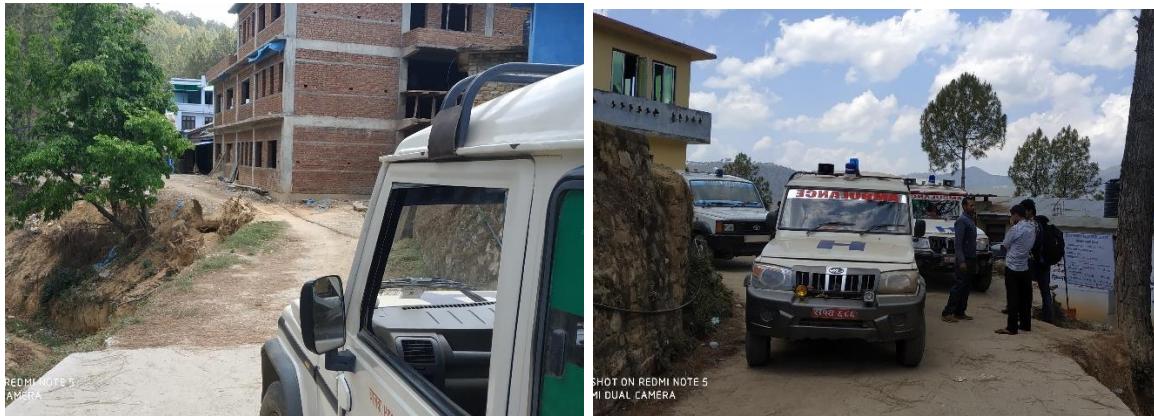
The Emergency Department is located at the rear site, and is hardly visible from the entrance area. The building does not comply with the Standard Guidelines for Design and Construction of Health Infrastructure 2017 – internal space arrangements and capacity are inadequate. The access road to the Emergency block is not of good quality, particularly to the rear of the new In-patient block (see Figure 10)

Figure 10: Access road to Emergency block

The road to the Emergency Department should be widened and upgraded at vulnerable points to ensure safe and easy access.

The Emergency Department should be re-located from its current position at the rear of the site to a more visible and accessible location nearer the entrance. The Emergency service block should be relocated as per the Standard Guidelines 2017.

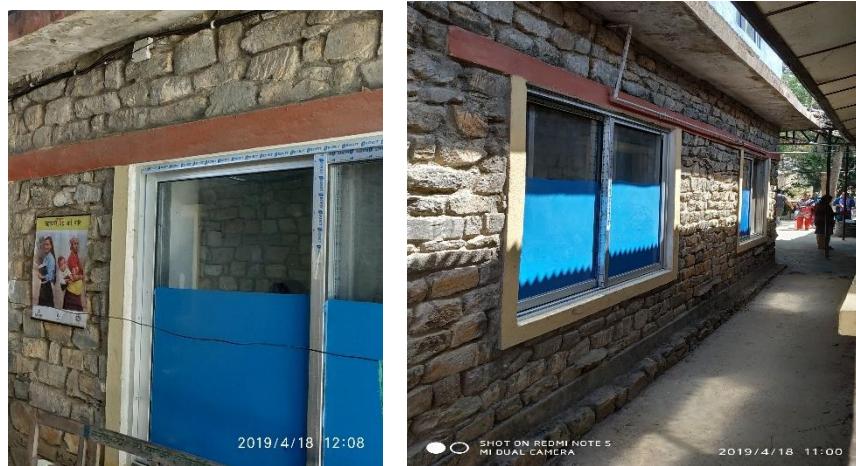
In some cases, wooden frame windows have been replaced by aluminium frame windows. As reported by hospital staff, this was carried out to increase light levels in the buildings (see Figure 11).

Figure 11: Replacement of wooden frames to windows

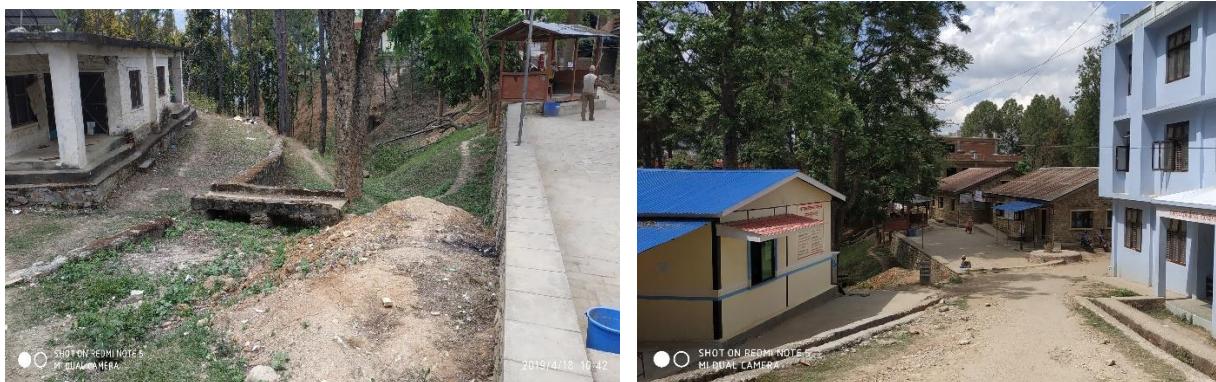
There are various storm water drainage structures in front of the hospital compound (see Figure 12). The NHSSP team observed that construction and demolition (C&D) waste had been dumped in a storm water drainage channel, increasing the risk of flooding. In addition, the hospital access road is basic earth, and has not been leveled or graded.

Figure 12: Drainage channel with C&D waste (left) and access road and drainage in front of hospital compound (right)

Dirt roads should be properly leveled and graded, drainage lines cleared and repaired. Public open spaces and pathways should be upgraded in line with landscape design principles and principle of universal accessibility.

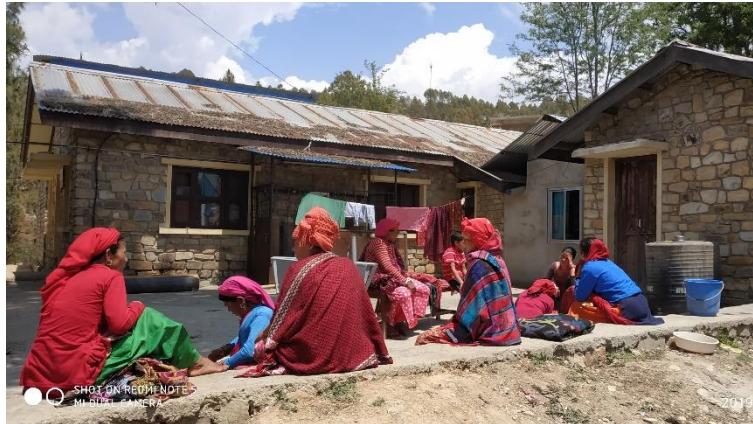
There is no heating system or heating, ventilation and air-conditioning (HVAC) units in critical care areas and the inpatient area. This is especially problematic in areas used for mother-child cases. Mothers and children take advantage of fresh air and sunlight when possible (see Figure 13).

Figure 13: Patients taking a sun bath

The Critical Care and In-patient areas (especially for mother-child cases) should be provided with heating system and / or HVAC services.

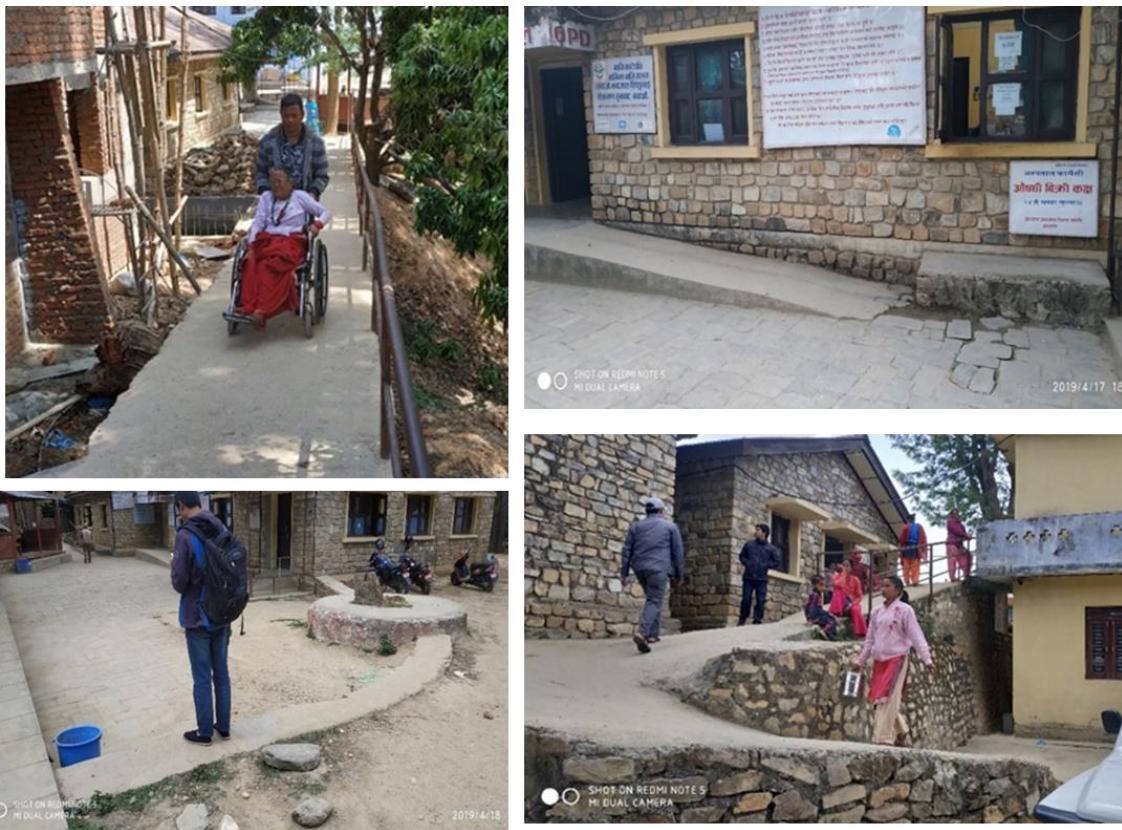
Most buildings on the site have ramps. Two levels of the hospital - Out-patient department (OPD) and In-patient area - are also connected via a ramp. However, an access ramp to the OPD block has been partially blocked by the construction of a concrete step for patients to access the medicine counter. This hampers wheelchair access and an example of poor design (see Figure 14). The ramp at the Emergency Block for second floor access does not meet design standards. There are no disabled-friendly access components at the entry to the hospital compound.

Figure 11: Ramps and accessibility
