Nepal Health Sector Support Programme III (NHSSP – III)

OVERVIEW AND REPORT RECOMMENDED RETROFITTING STANDARDS FOR HEALTH INFRASTRUCTURE FACILITIES

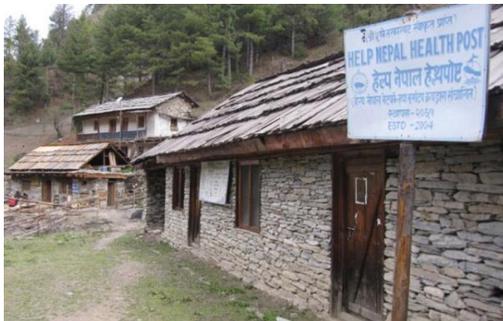
Dry stone masonry

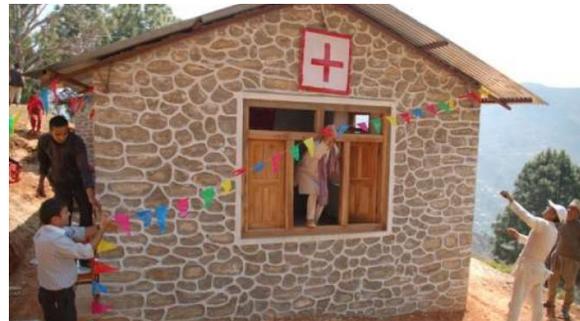
Stone masonry and mud mortar (with cement pointing)

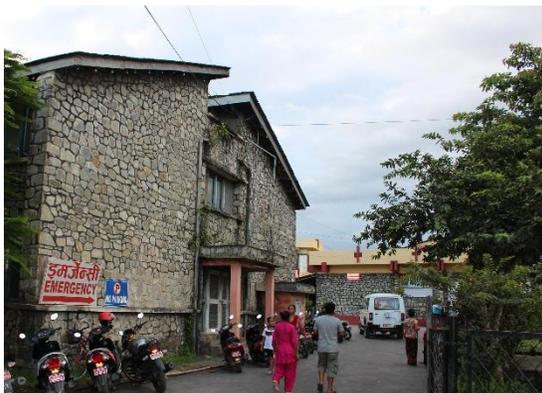
Stone masonry and cement mortar

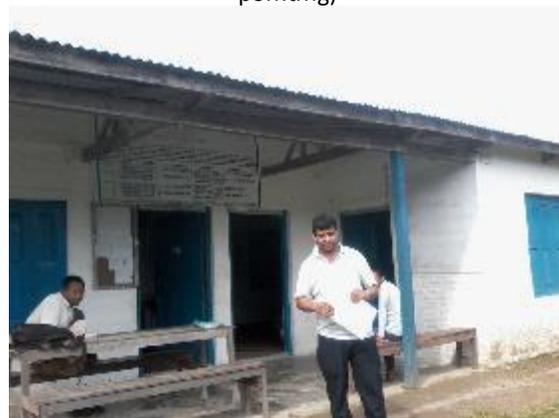
Brick masonry with mud mortar

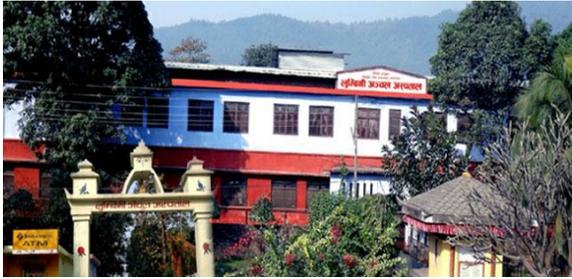
Brick masonry with cement mortar (note top story. Unlikely to be part of the original design)

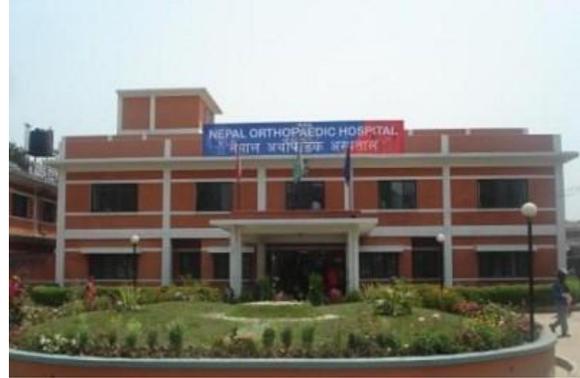
Concrete frame with masonry infill

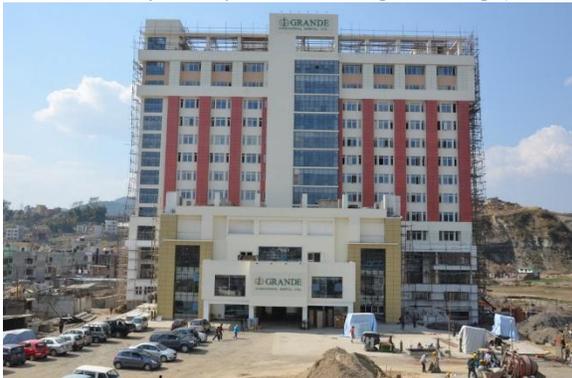
Concrete frame building

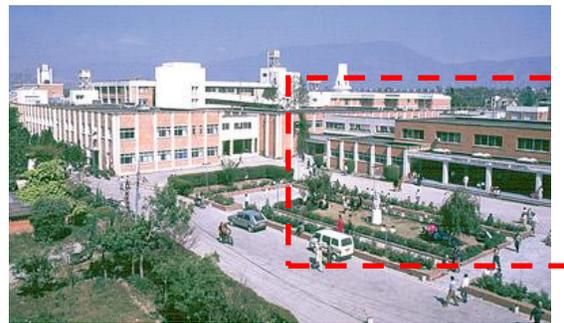
Concrete structural wall building

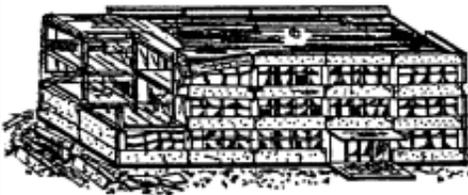
<p>Grade 3: Substantial to heavy damage (moderate structural damage, heavy non-structural damage)</p> <p>Cracks in columns and beam column joints of frames at the base and at joints of coupled walls. Spalling of concrete cover, buckling of reinforced rods. Large cracks in partition and infill walls, failure of individual infill panels.</p>

<p>Grade 4: Very heavy damage (heavy structural damage, very heavy non-structural damage)</p> <p>Large cracks in structural elements with compression failure of concrete and fracture of rebars; bond failure of beam reinforced bars; tilting of columns. Collapse of a few columns or of a single upper floor.</p>

Figure 5. European Macroseismic Scale 1998 (Grunthal, 1998)

The European Macro-seismic Scale (EMS 98) defines various DGs due to earthquake shaking applicable to buildings. As an example, various damage grades for a reinforced concrete frame building are reproduced in Figure 5.

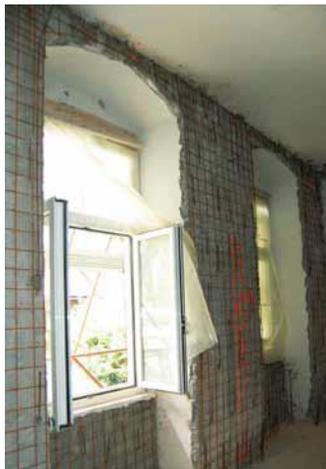
Figure A.12. Jacketing of a masonry wall (Bothara & Brzev 2011)

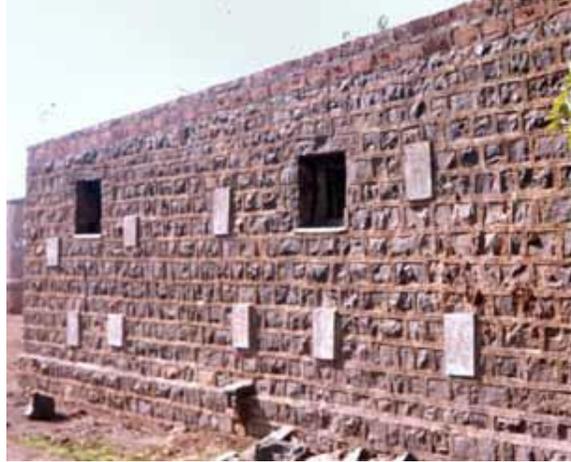
Figure A.13. Stitches to multi-wythe stone masonry wall (Bothara & Brzev 2011)
