REPORT ON DETAILED SEISMIC ASSESSMENT & RETROFIT DESIGN OF BHAKTAPUR HOSPITAL, BHAKTAPUR, NEPAL

JULY, 2018

Nepal Health Sector Support Programme - III
(NHSSP-III)

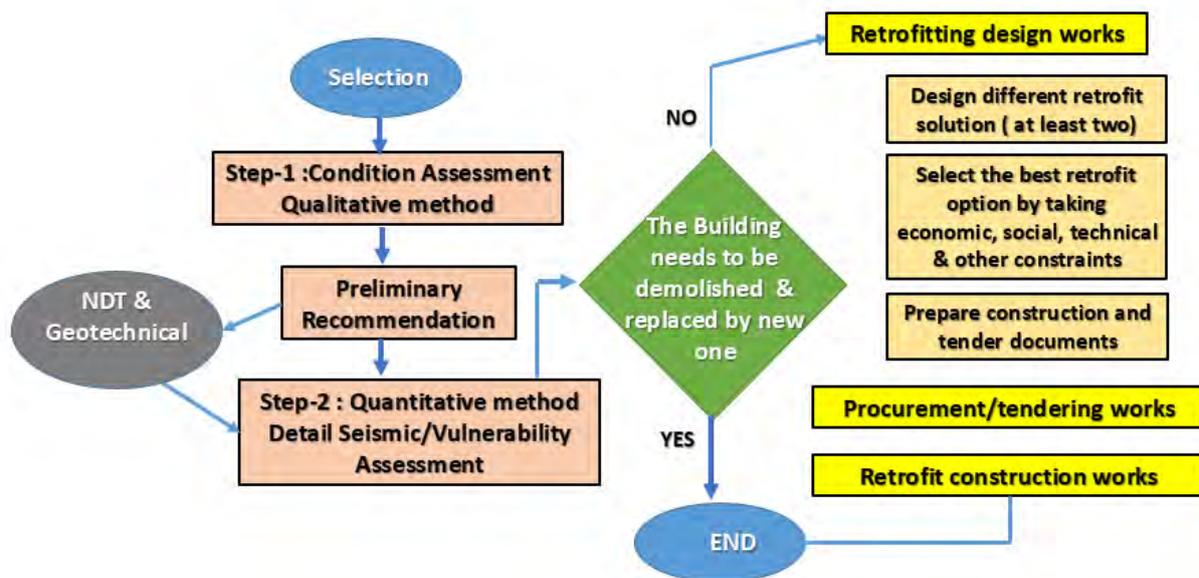
Figure 1: Flowchart of overall process of detail seismic assessment and retrofitting design

Undertaking retrofit works is far from being a single activity; rather, it is a feat of multitasking accomplishments, each of which is essential in order to achieve successful execution of a retrofit project. The proposed retrofitting procedure in the program includes a net of activities as shown in Figure 1.

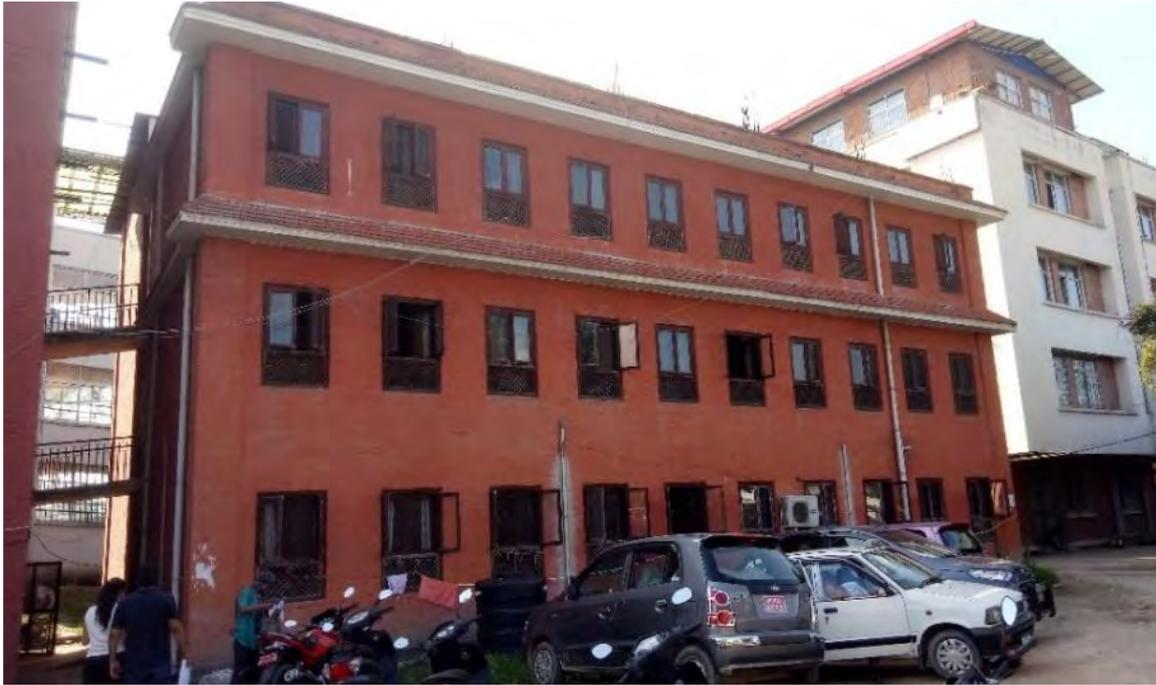
Figure 4: Photographs of Maternity Block

The maternity building is a rectangular three-story reinforced concrete structure with unreinforced masonry infill. It has five bays in the longitudinal direction, and two bays on one either side of a central corridor, in the lateral direction. There is a reinforced ramp at the southern elevation, which connects to the main hospital building. It is a RCC structure with brick cement mortar as infill wall. All the floors are concrete slabs. The building has no significance damage in structural and non – structural elements. Reinforcement of roof slab and column rebar on roof is exposed. 230mm of brick wall stretches from the first landing to roof level. The first landing of the staircase is a cantilever slab projecting about 500mm outside from the columns. Figure 4 shows photograph of the Maternity Block.

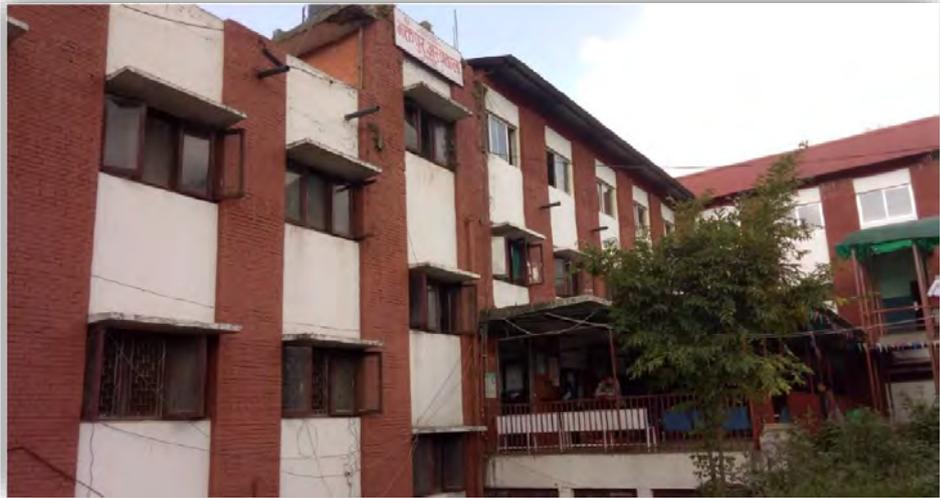
Figure 5: Main Block

This building is used for the outdoor patient department (OPD), general therapy and other related issues. There are operation theatre, preparation room, store, machine room, wards, changing rooms

and toilets. In the first floor there are dental OPD rooms, X-Ray room, medicine supplier room, surgical room, physiotherapy room, offices and toilets. In the second floor there are OPD rooms, staff rooms, store rooms, nurse room, Ear Nose Throat (ENT) medical room, and endoscopy room.

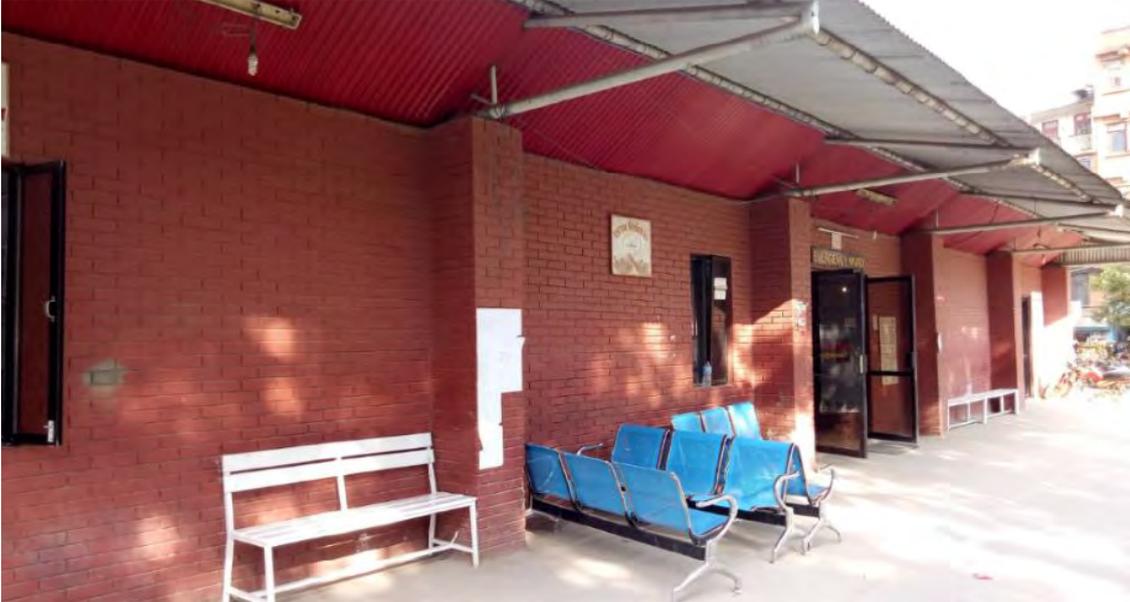
Figure 6: Front Facade of Emergency Block

The Emergency Block is a one story reinforced masonry building with hollow concrete blocks in cement mortar. The roof of the building is made up of steel truss and CGI sheet resting on the walls. Buttress walls are constructed at the corners and also along the wall facing east and west direction (**Error! Reference source not found.**) shows a photograph of the Emergency Block.

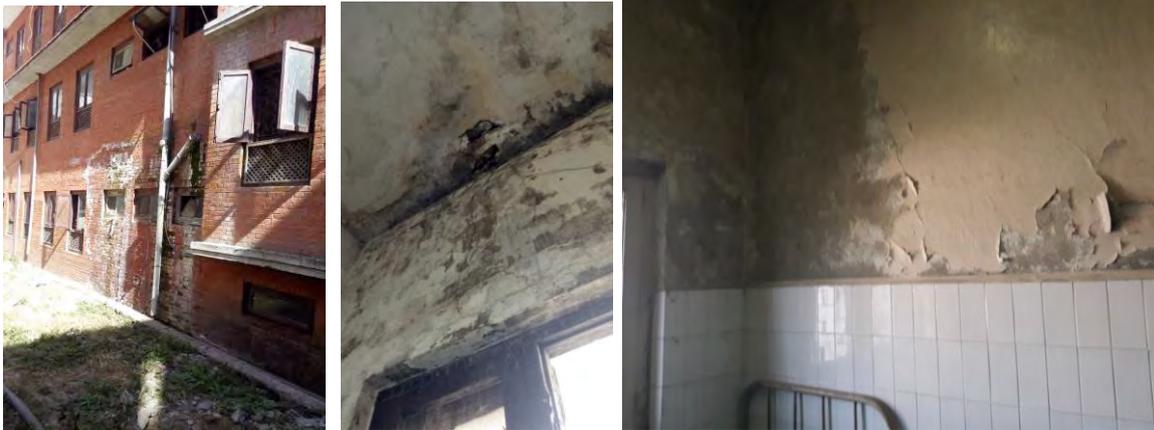
Figure 6: Seepage in Maternity and Main building

Most of the buildings of WRH have serious seepage issues due poor drainage system and lack of maintenance as shown in the following photos.

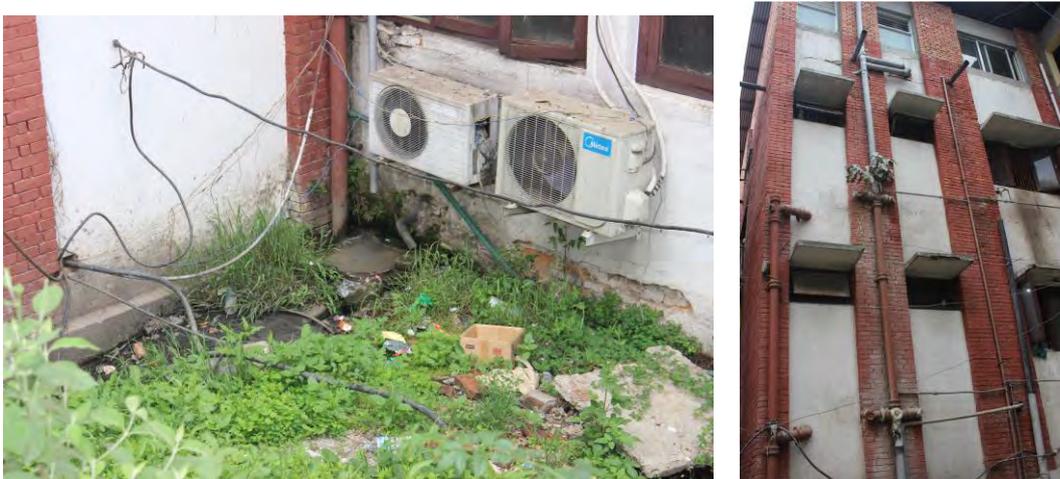
Figure 7: Sewage problem in Main building

Water seepage, lack of maintenance of water and sewage pipes, growth plants on the building and other environmental factors are causing deterioration of the building. It is likely that the low drainage capacity and high moisture content in the bearing soil is also contributing to deterioration of the building

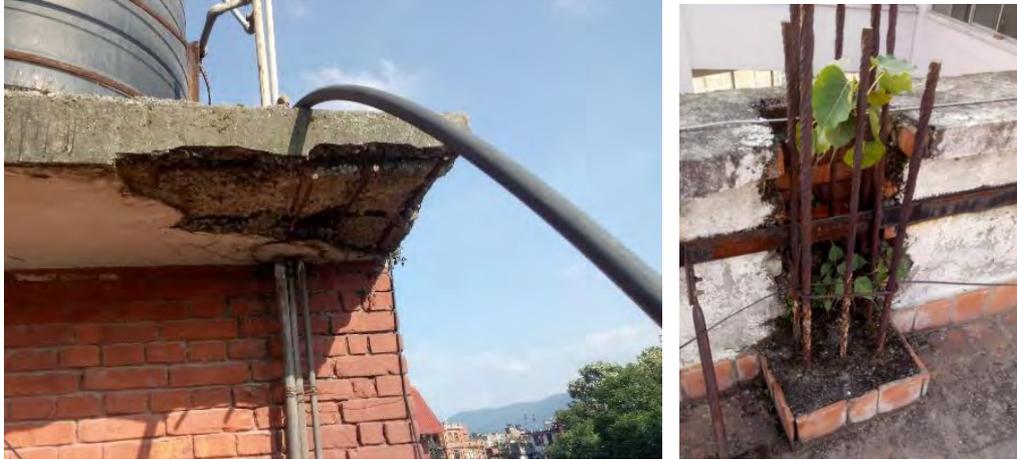
Figure 8: Corrosion in Main and Maternity blocks

Growth of plants on stair roof, spalling of concrete in the cantilever slab of the top floor and corrosion of slab rebar were observed

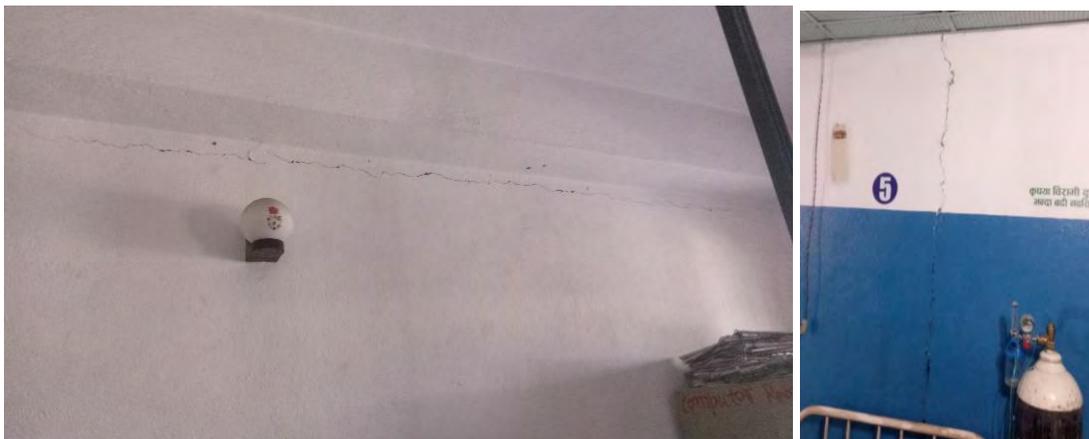
Figure 9: Cracks in walls

No significant cracks were observed in all the buildings. Only minor cracks were visible in the infill masonry panels that have slightly debonded from the surrounding concrete frame in Maternity Building. Cracks were observed in the lintel of door entrance of the main building. In Emergency block, a vertical cracks next to the buttresses were observed in the exterior wall of the building.

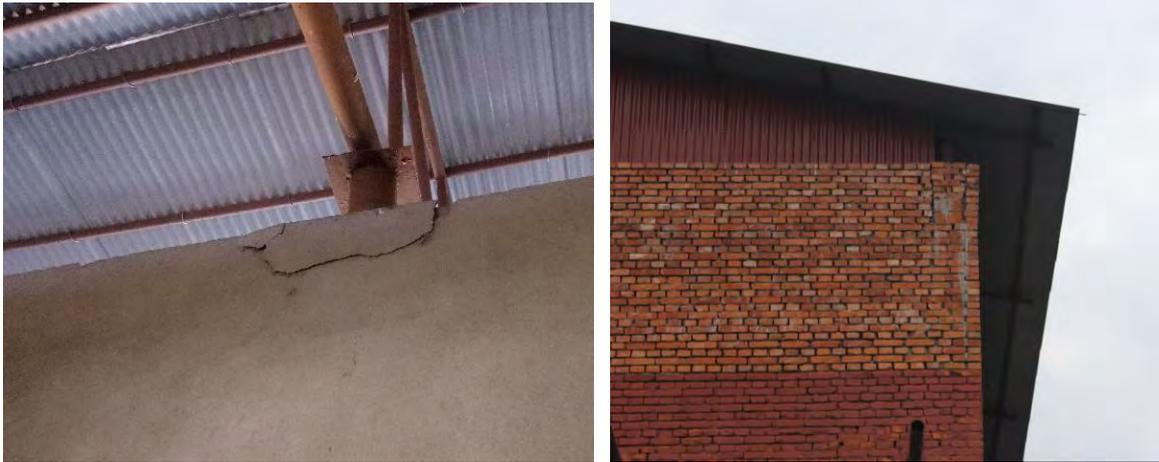
Figure 10: Cracks at truss and wall joints of Main Blocks

Some major cracks, especially at the joint of roof truss and wall were found in top floor walls of main building that was added later

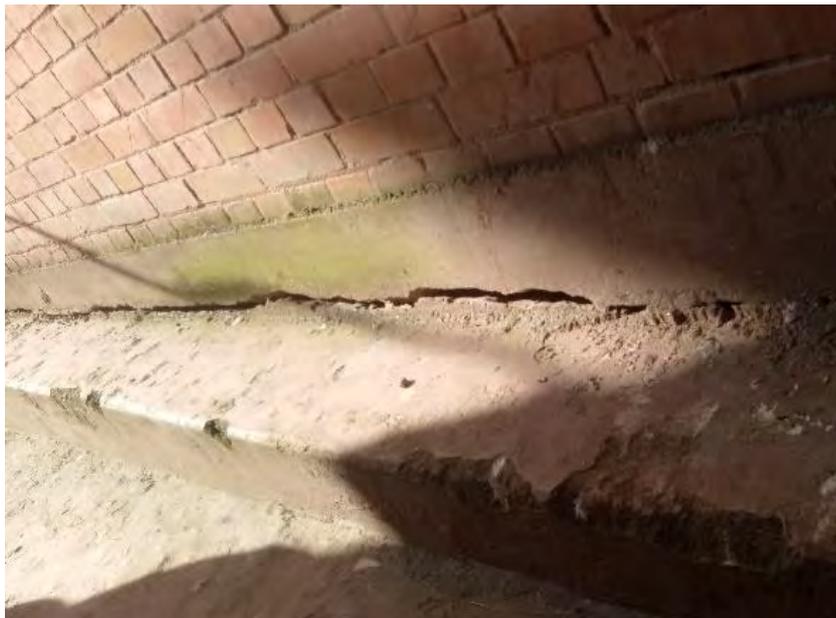
Figure 11: Settlement cracks in Maternity Block

Spalling of plaster in the corner of the foundation was observed in the Maternity Block. It is possible that this deterioration could be due to the Settlement of ground during an earthquake. However, the major cause of this spalling was not known at site and shall be verified only after the detail investigation

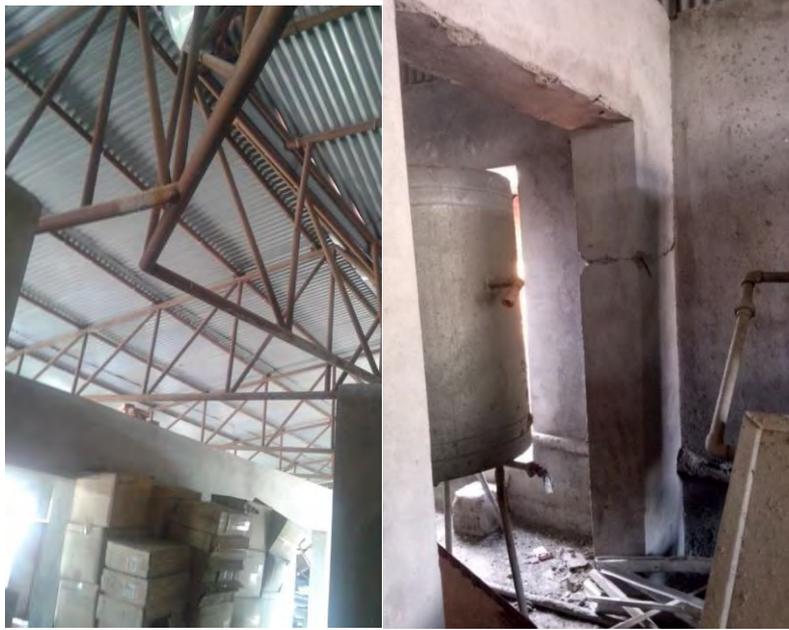
Figure 12: Construction errors in Main Block

In top floor of main building that was added later, poor construction of wall and truss were observed as shown in the photos

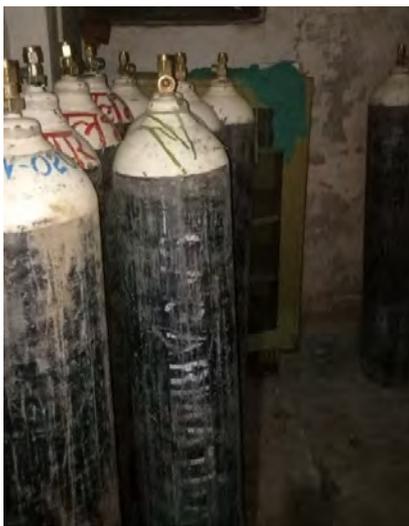
The tall shelves were kept unbraced / unanchored as shown in various areas of the hospital

Figure 13: Oxygen Cylinder Kept Unbraced

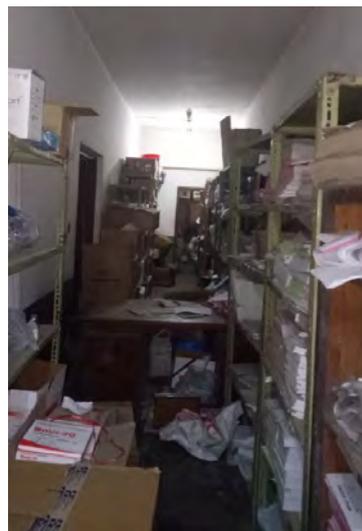
Shelves Kept Unanchored in the passage

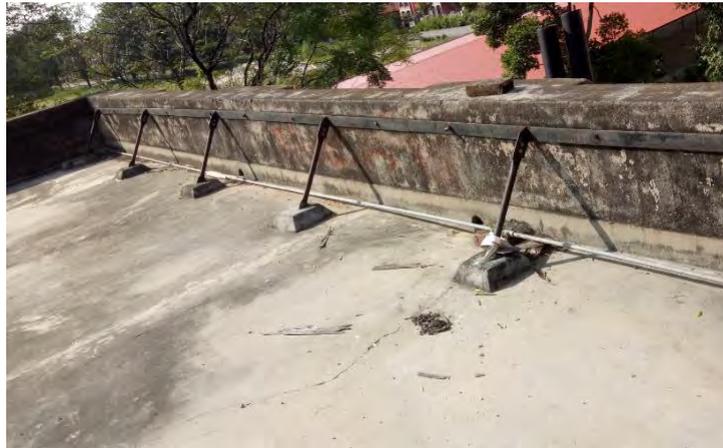
Figure 14: Parapet wall anchorage

Parapet of the main block were braced using the steel strut as shown in following figure.

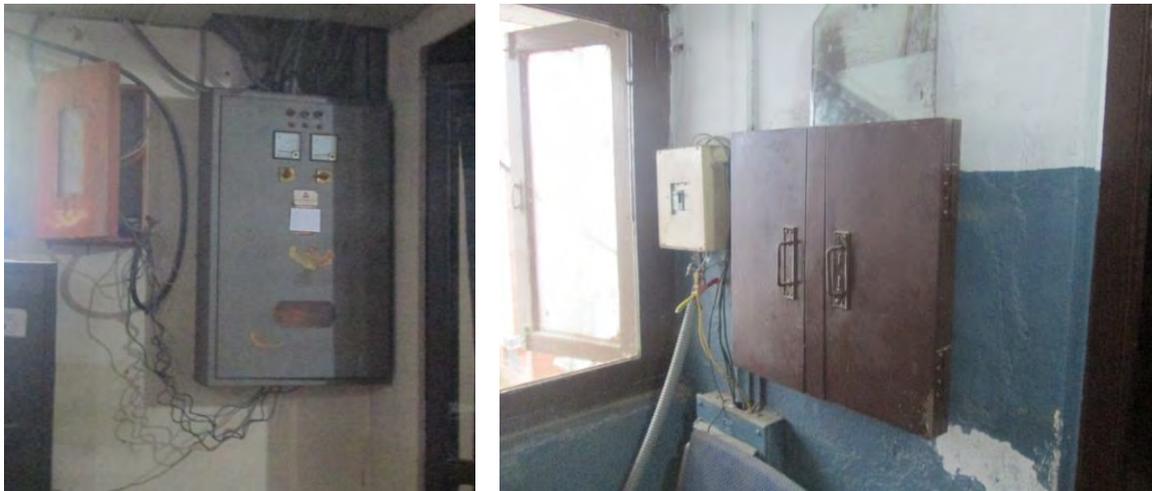
Figure 15: Electric fittings at Main and Emergency blocks

It was observed that electric fittings were very poor and hazardous and deficiencies

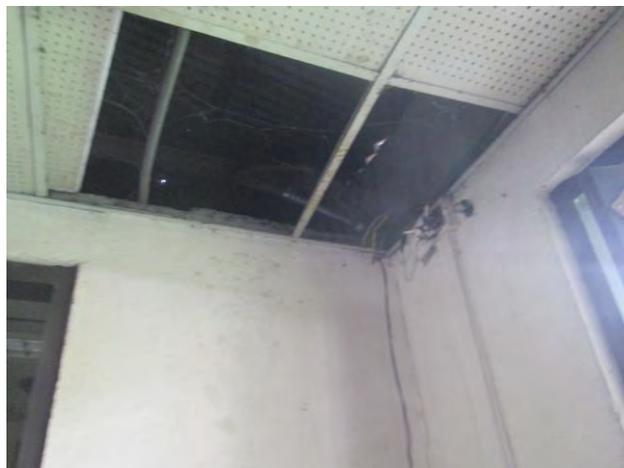
Figure 16: False ceiling of Emergency block

There were some deficiencies in the part of false ceiling of Emergency block as shown in the following figures.

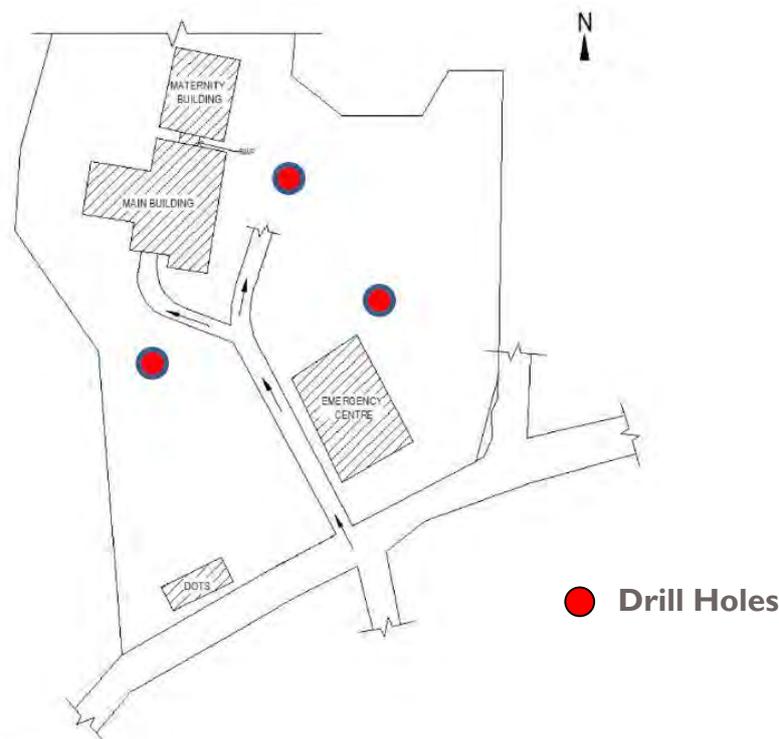
Figure 19: Location of Drill Holes for Geotechnical Investigation

The aims of geotechnical investigation are to understand the geology and engineering properties of existing soil at the Bhaktapur Hospital. Three bore holes of 20m depth were investigated during this investigation. The locations of the bore holes are as shown in Figure . The intent of this test is to get:

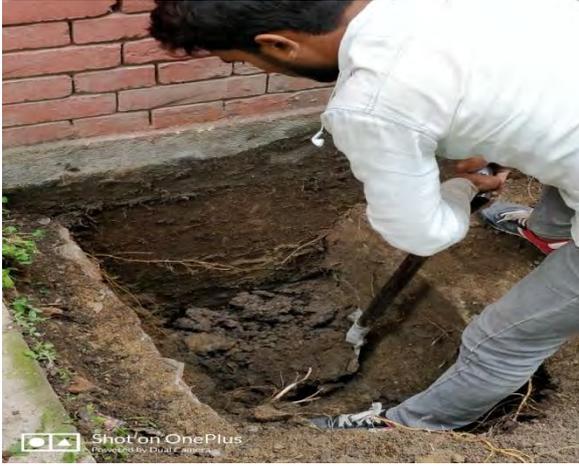
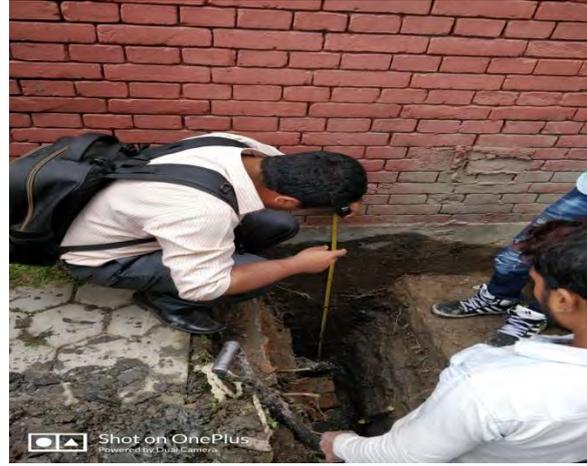
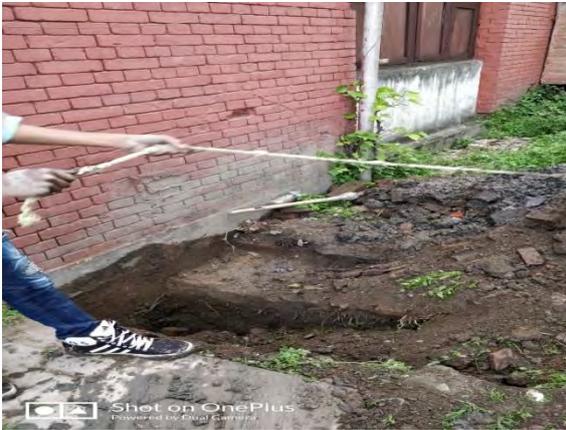
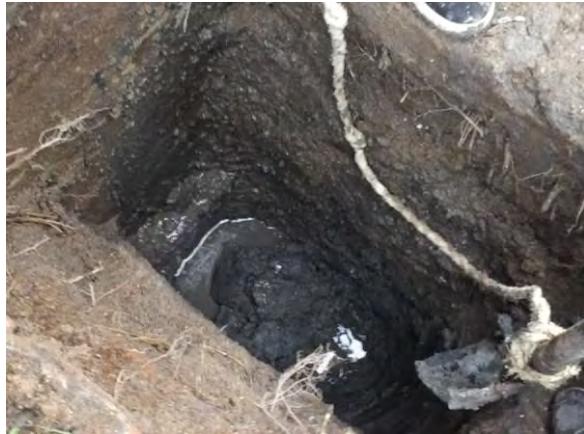
Figure 20: Foundation Exploration of Masonry Block

- Tie beam is not found during excavation.
- Step wall foundations of brick masonry in cement sand mortar with concrete pad is found.
- The foundation depth, size and thickness are found as present in figure below.
- Water seepage in foundation is found.

S.N.	Description	Finding (Bhaktapur)
1	Soil Type	Silty Clay
2	Foundation Depth	1300mm
3	Foundation Size	1350 mm
4	Footing thickness	150+250=400 mm

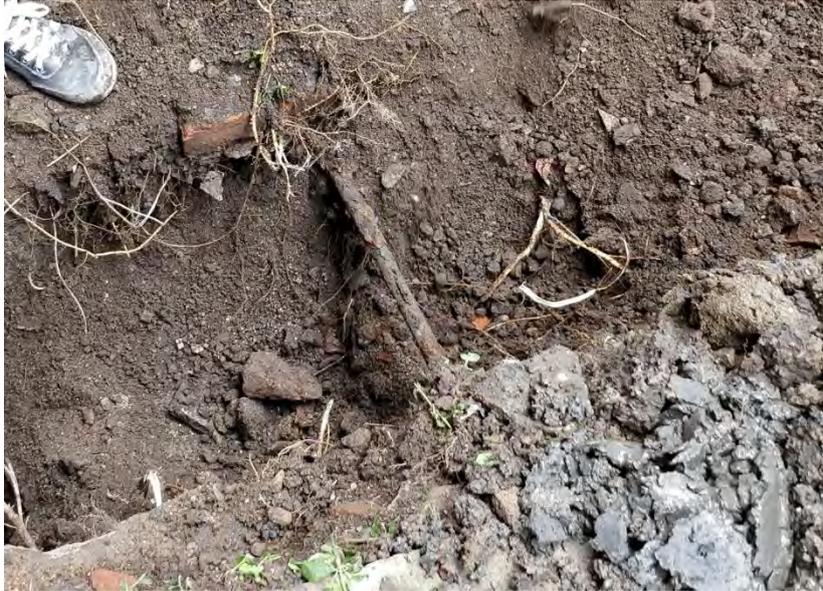
Figure 21: Water Supply Pipe Lines

Note: There is water seepage and water supply lines running found during foundation exploration.

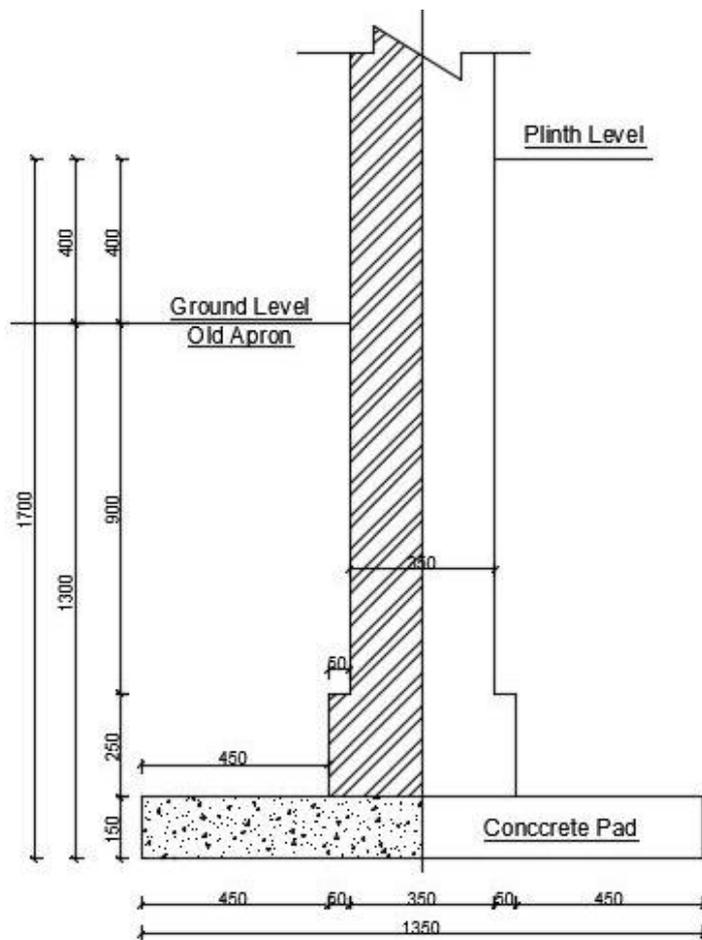
Foundation Measured During Excavation
Main Block (Bhaktapur Hospital)

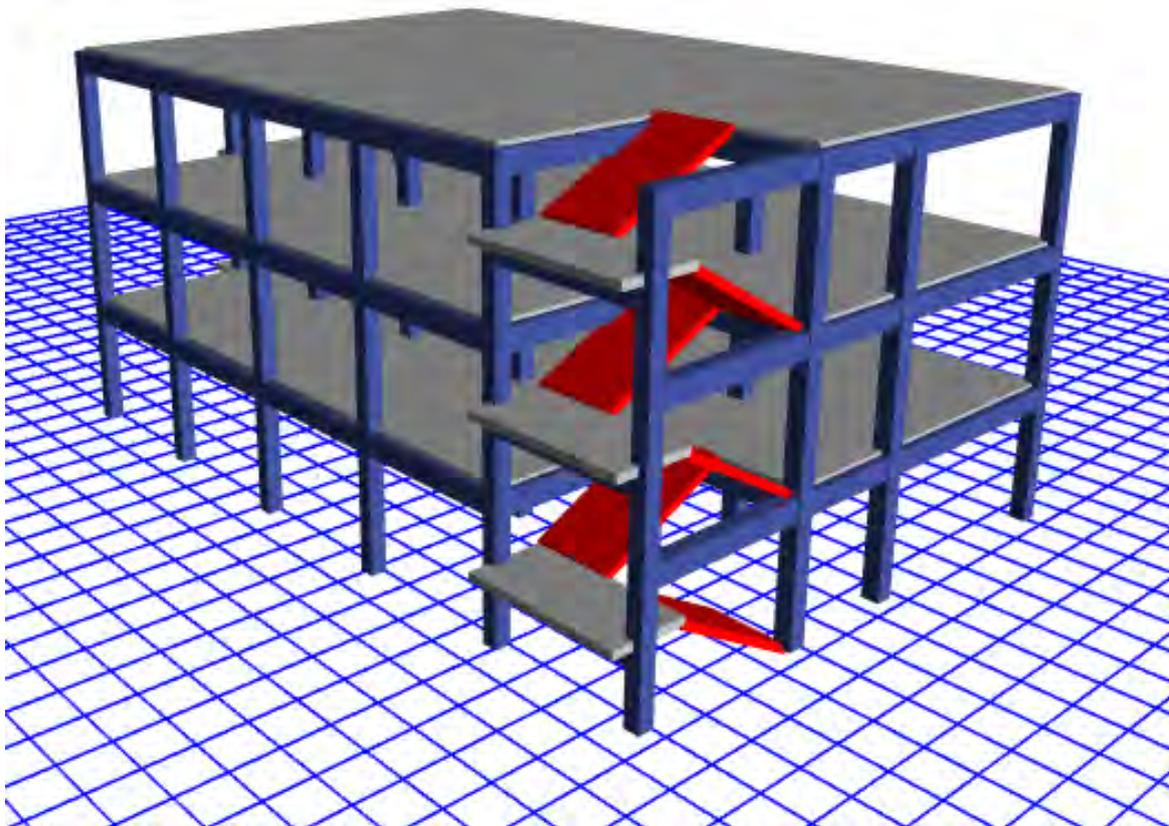
Figure 22: 3D Model of Building

- All the supports are fixed at plinth level. Fixed support conditions are assigned for columns while hinge supports conditions are assigned for masonry walls.

- No ties beams are modeled. So ground floor wall and partition loads are not added, hence considered passing on the foundation directly.
- Structural member sizes are modeled as per field measurement.

- Crack section are modeled as per recommended by IS 15988: 2013 Table 2.

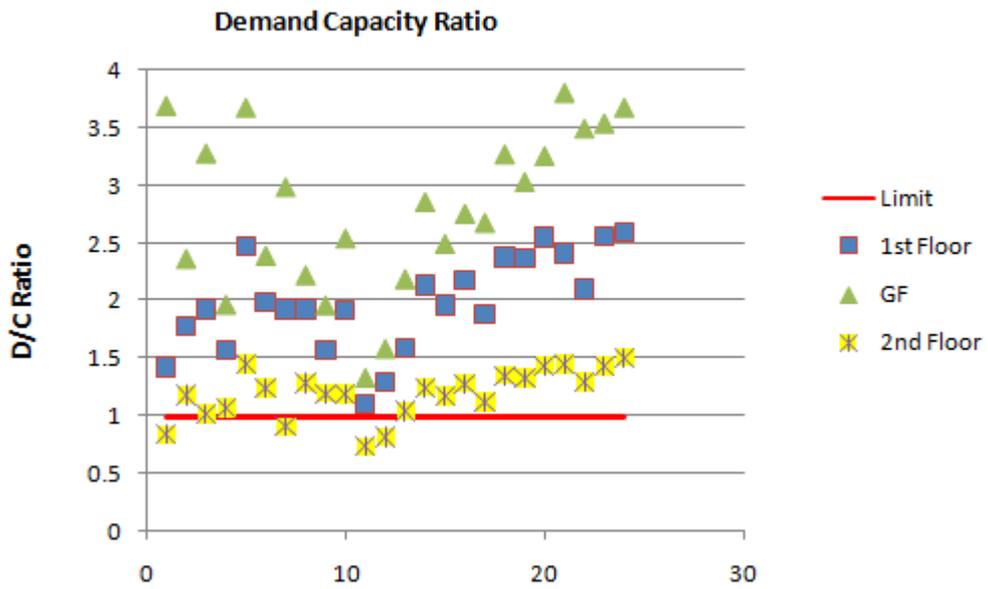
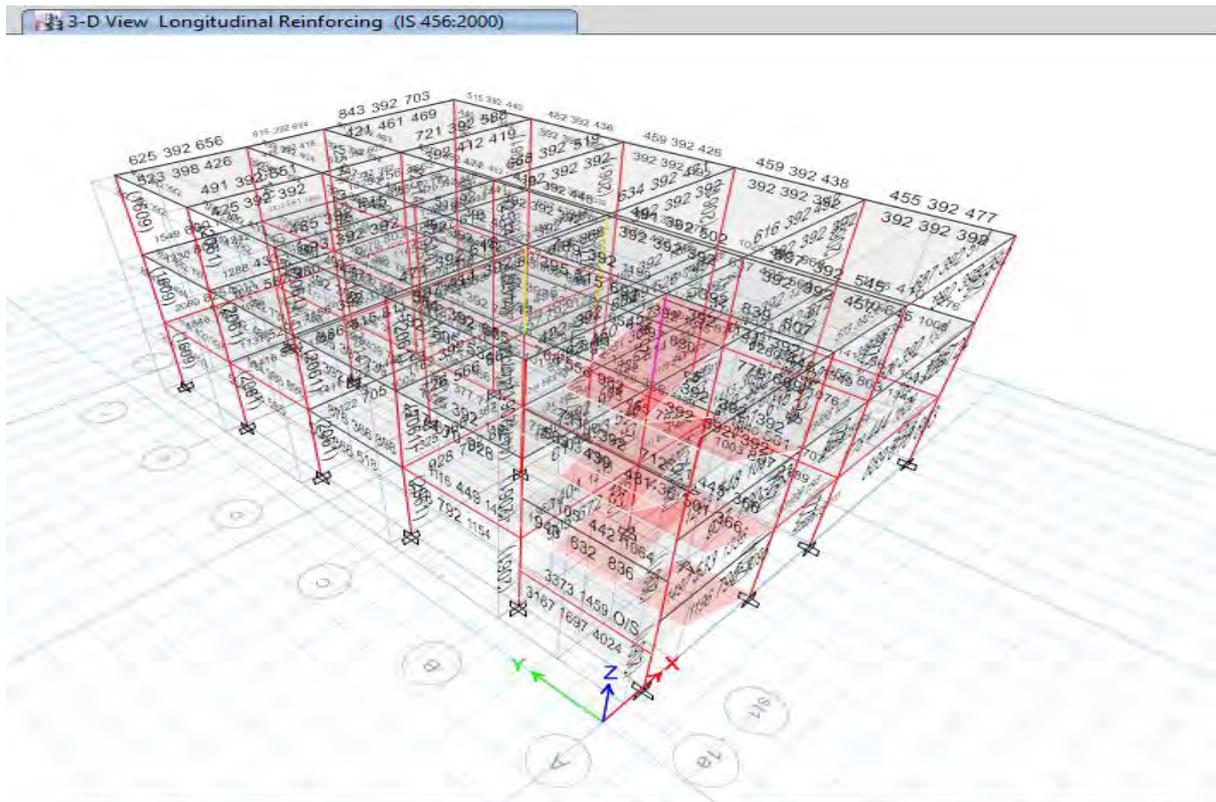
Figure 23: Demand Capacity Ratio of Structural Member (Column)

The seismic demand of each structural member (Columns) for earthquake loading as explain above under heading seismic load are computed and Structural members capacity are checked for earthquake demand. The demand capacity ratio below one “1” means the structural member is safe and above one “1” means the structural member is unsafe. The demand capacity ratios for structural members are shown in **Error! Reference source not found.** below.

- The buildings does not comply with codal requirement for story drift check. Hence the building is not safe in drift.
- The building has torsional irregularity (IS 1893:2002)
- But the building does not have soft storey, mass irregularity, and eccentricity check. (IS1893:2002)
- The shear areas of column are found exceeding the safety limit for seismic demand as per relevant Indian Standard Codes. (IS 1893:2002)
- The structural column members' capacities are found insufficient for seismic demand as per relevant Indian Standard Codes. (IS 1893:2002)

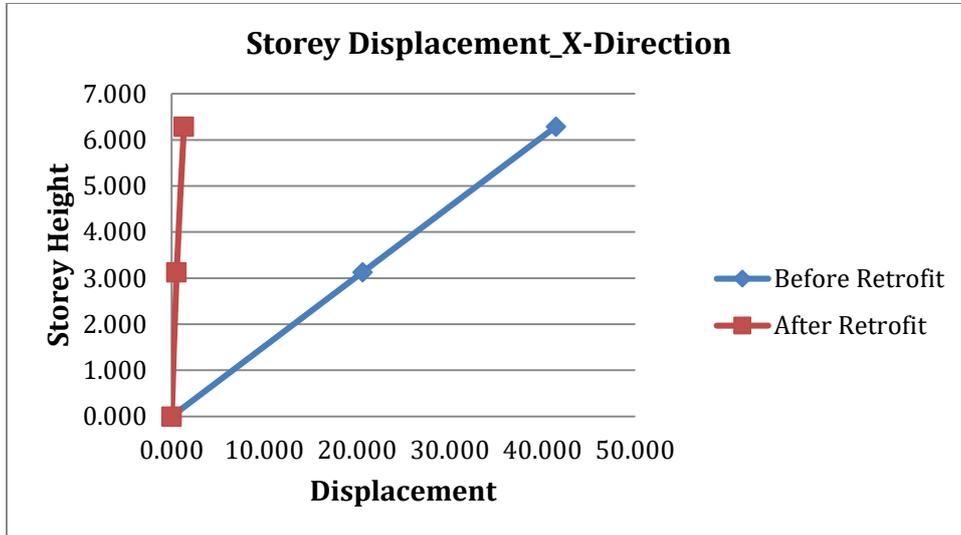
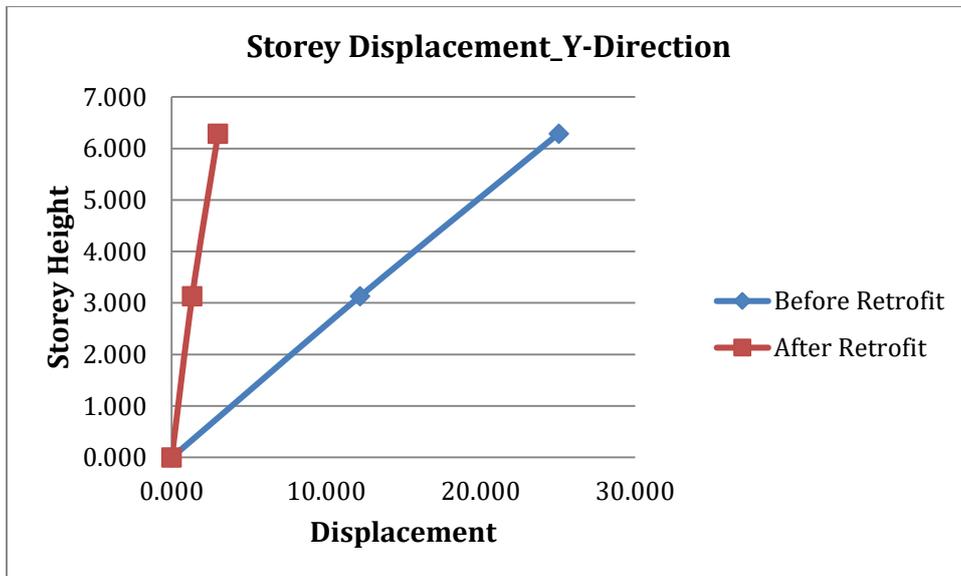
Figure 25 : Drift comparison before and after retrofit along X direction

Story	Elevation	X-Dir	Y-Dir	Drift X	Drift Y
	m	mm	mm	%	%
Story3	9.480	2.151	4.495	0.026	0.047
Story2	6.290	1.329	3.005	0.025	0.053
Story1	3.130	0.532	1.327	0.017	0.042
Base	0.000	0.000	0.000	0.000	0.000

It is seen that drift does not exceed the code prescribed value of 0.004 times story height .Thus the drift check seems to comply with the safety value mentioned in the code.

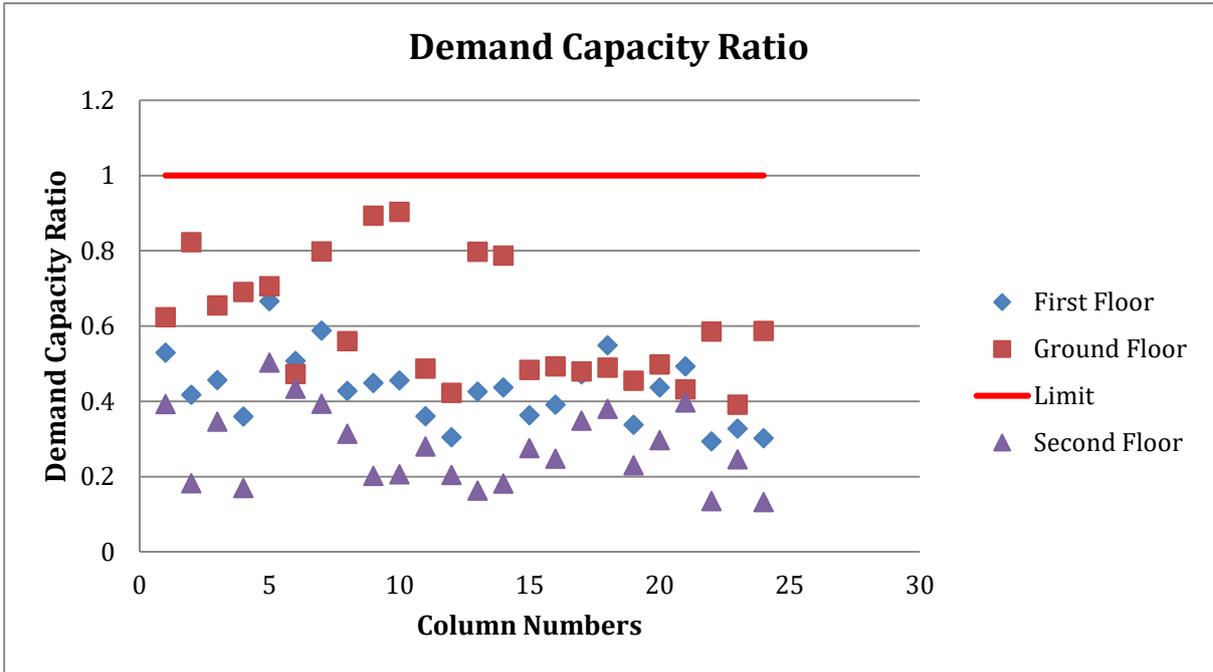
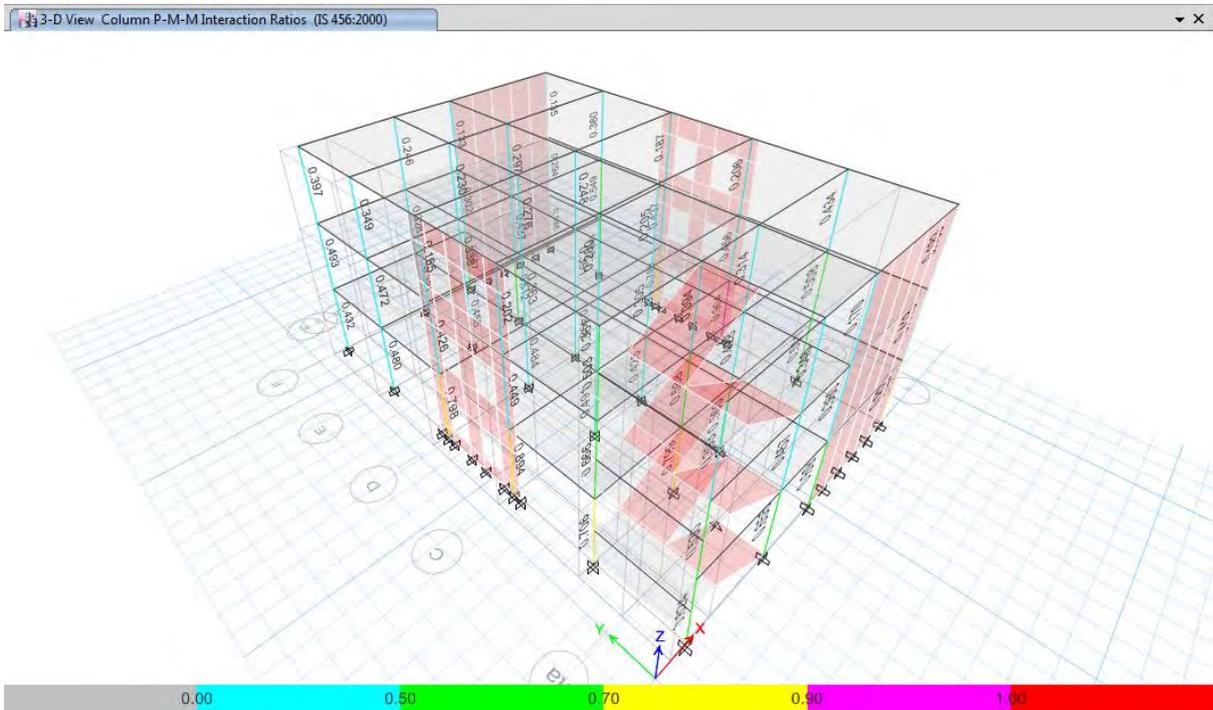
Figure 4: Demand Capacity Ratio of Structural Member (Column) after Retrofit

The seismic demand of each structural member (Columns) for earthquake loading as explain above under heading seismic load are computed and Structural members capacity are checked for earthquake demand. The demand capacity ratio below one “1” means the structural member is safe and above one “1” means the structural member is unsafe. The demand capacity ratios for structural members are shown in **Error! Reference source not found.** below.
